GEOTECHNICAL ASSESSMENT

Vermilion Airport Rehabilitation – Runway and Taxiway Vermilion, Alberta

**Town of Vermilion
c/o McElhanney**

Project File #: PG23-1717.R1

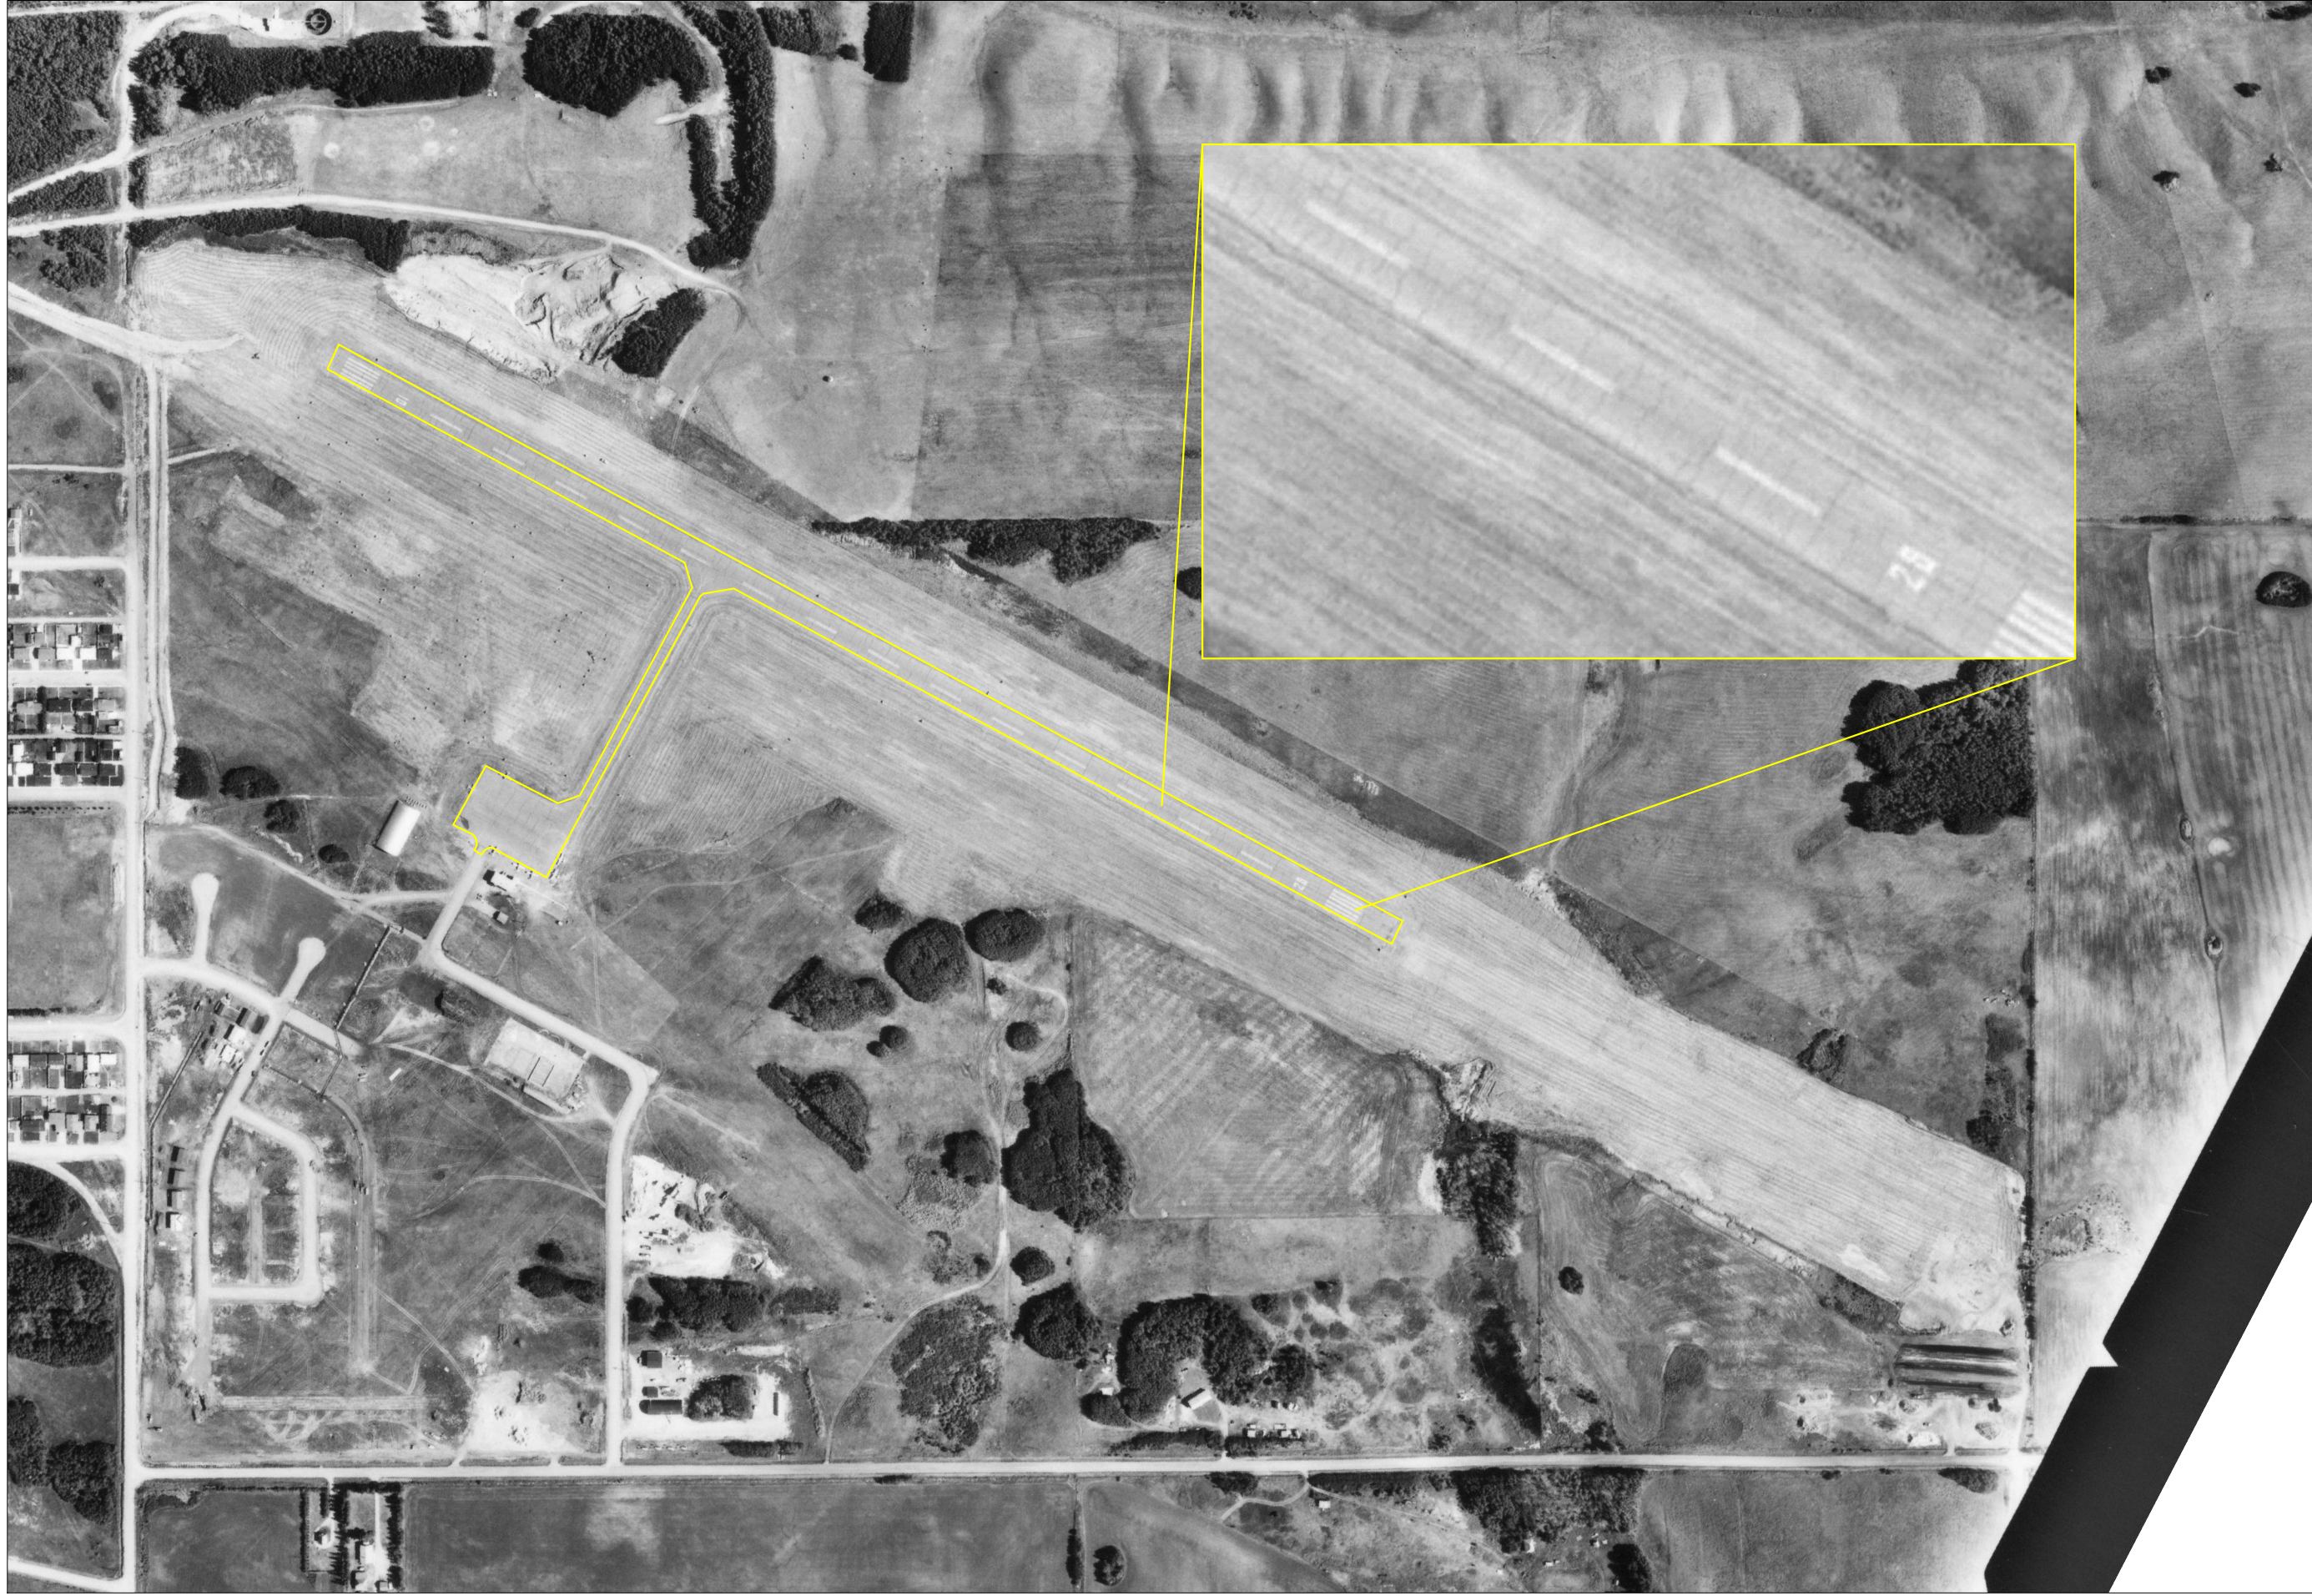
1977 Aerial Photograph of the Site

| Year | Description |
|---|--|
| 1977 | The airfield was clearly visible. Evidence of cracking was visible across the entire airfield alignment. |

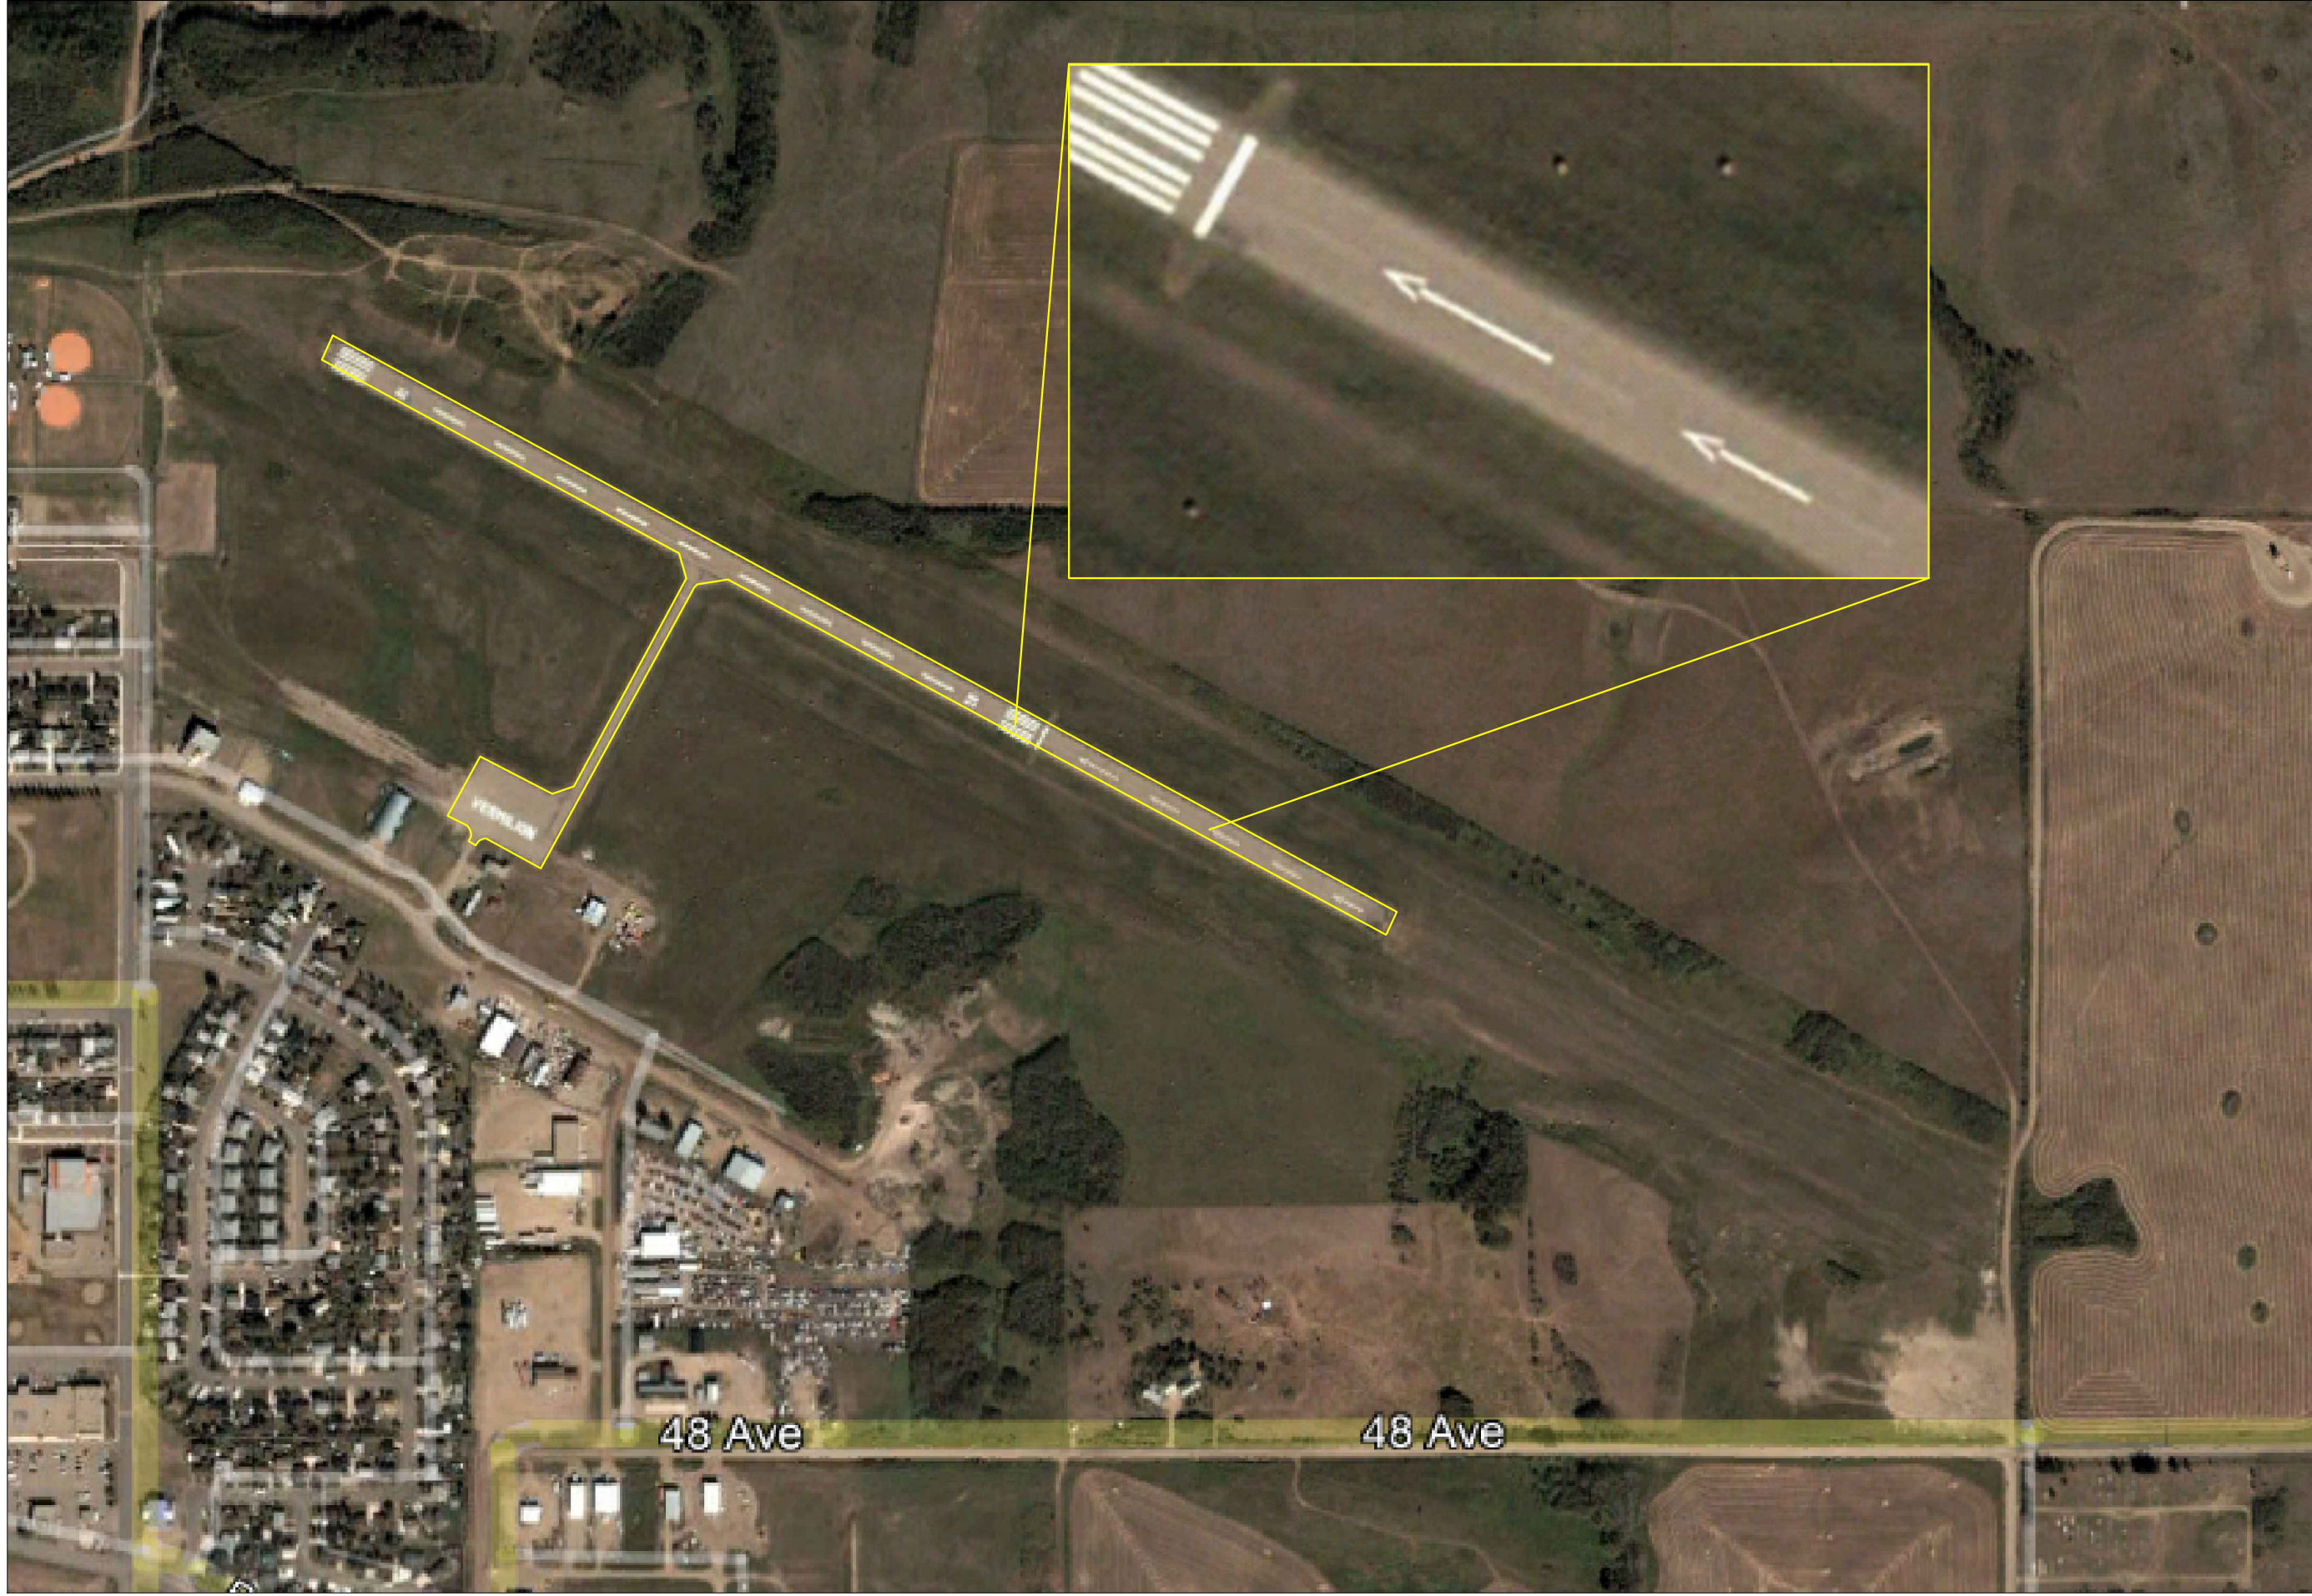
DRAWING TITLE: 2003 Aerial Photograph of the Site

| Year | Description |
|---|--|
| 2003 | It appeared that the existing airfield pavement was re-surfaced. There was no sign of cracks at this time. |

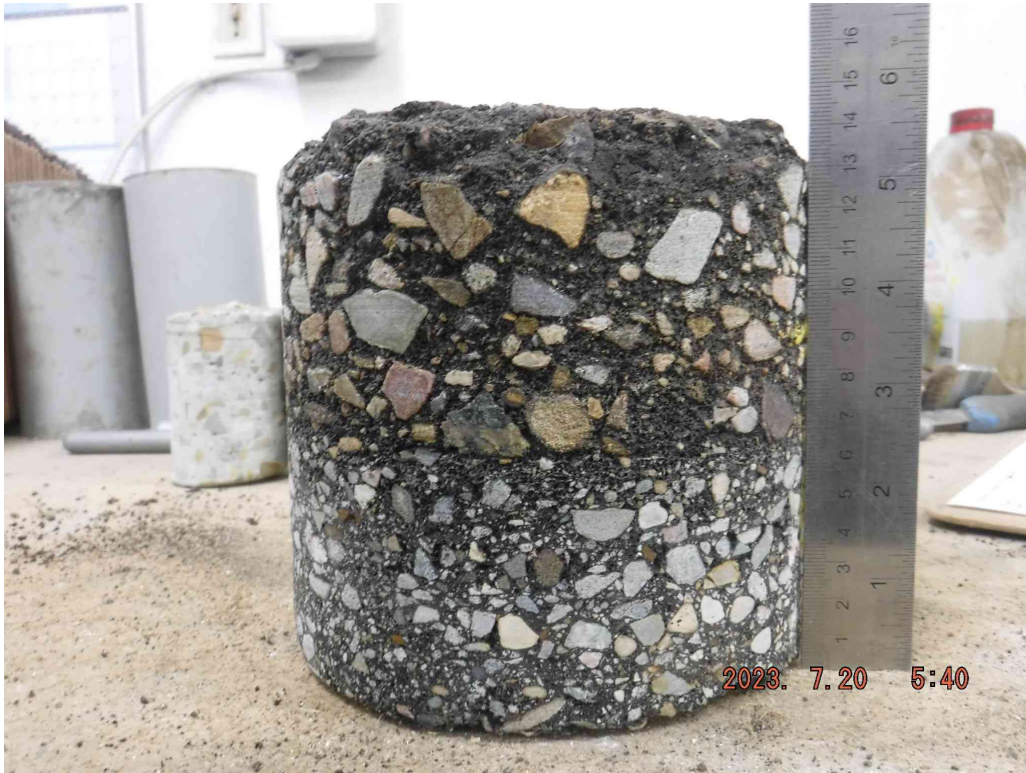
Photograph 1: Asphalt core from the location of BH23-2

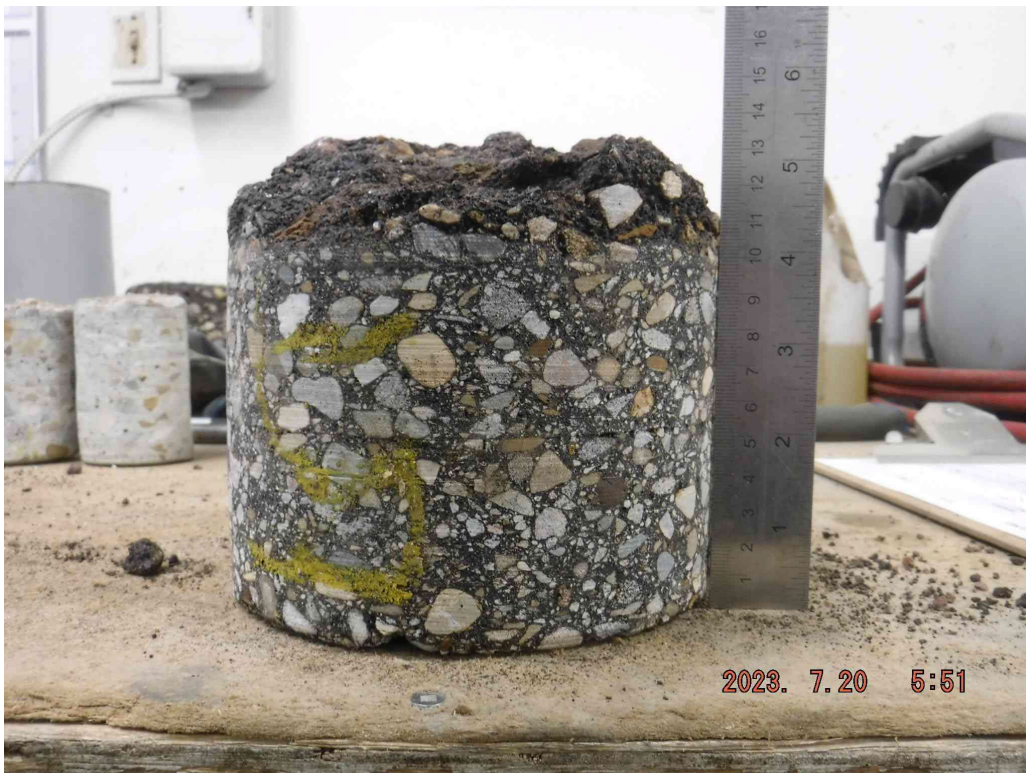
Photograph 1: Asphalt core from the location of BH23-5

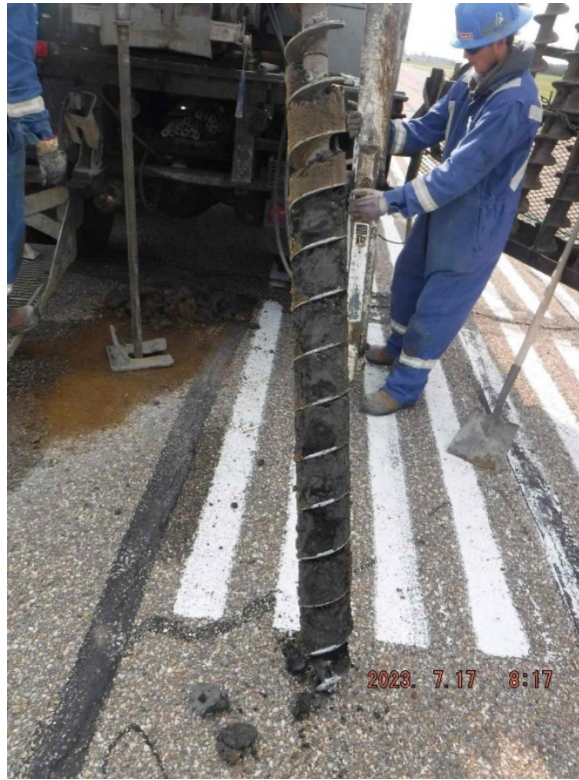
Photograph 3: Looking at auger retrieval (depths of 0.3 to 2.3 m at BH2-02)

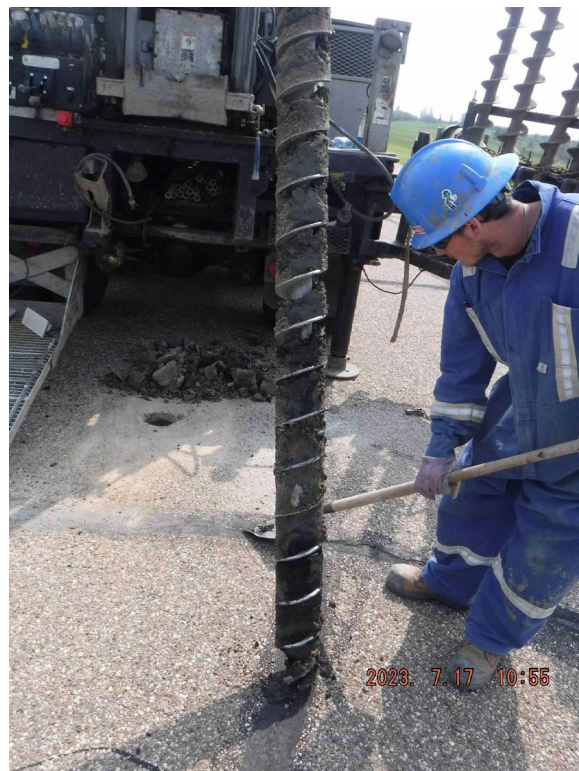
Photograph 4: Looking at auger retrieval (depths of 1.5 to 3.0 m at BH23-06)
